How Does the Storm From Last Friday, March 2, 2018 Rate ?

Newdan Engineering, LLC – Daniel Bruno Ferrari, P.E.
300 International Drive, Williamsville, New York. 14221
Telephone : 716 – 689 – 3291 Web Site : www.newdan.com

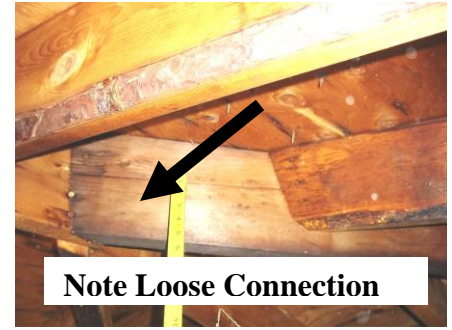
The roof rafters and/or roof framing of many older homes would most likely not meet current building codes and snow loads on these roofs can result in cracking of the roof rafters as seen in the picture to the left and/or loose connections for the roof rafters and/or roof framing members that can be seen in the picture to the right

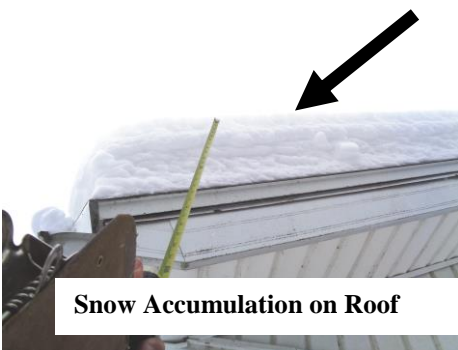
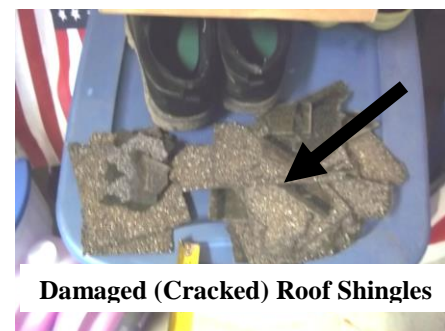
Winter brings many challenges to homeowners including the roof surface. It is best to avoid rooftop snow removal, but when it must be done, it is imperative that it be done in a proper and/or safe manner. Try to use a “snow-rake” to remove the snow from ground level and avoid walking on the roof surface. Also use a proper tool as to avoid damage to the roof surface. The colder winter weather makes roof shingles brittle and prone to cracking
